**WEST VIRGINIA DEPARTMENT OF ENVIRONMENTAL PROTECTION  
WV OIL AND GAS CONSTRUCTION STORMWATER PERMIT**

<b>FACILITY NAME:</b>	Mountain Valley Pipeline Project		<b>REG. #</b>	<b>EXPIRE DATE:</b>
<b>PERMITTEE</b>	MOUNTAIN VALLEY PIPELINE, LLC		WVR310667	5/13/2018 Extended: 12/31/2018
<b>ADDRESS/PHONE:</b>	Attn: MATTHEW HOOVER 625 LIBERTY AVE, ST 1700 PITTSBURG, PA 15222 7248733645			
<b>LOCATION:</b>	Leivasy		<b>Entry Date/Time:</b>	6/6/2018 1000
<b>COUNTY:</b>	Nicholas/Greenbrier/Fayette		<b>Exit Date/Time:</b>	6/6/2018 1700
<b>Site Representative /Phone</b>	Cary "Muggs" Cheek/ 318-669-6999 (Lead EI) & Adam Ledbetter (EI)		<b>PHOTOS</b> <input checked="" type="checkbox"/>	
<b>CO-PERMITTEE:</b>		<b>ADDRESS:</b>		
<b>SITE OPERATOR:</b>	Price Gregory		<b>ADDRESS:</b>	920 Memorial City Way, Suite 600, Houston, TX 77024
<b>PERMITTED ACREAGE</b>	4311	<b>WEATHER:</b>	Clear	<b>LAST INSPECTION:</b> n/a
<b>RECEIVING STREAM(S)</b>	UTs/Gauley River/New River/Kanawha River			<b>NOV: 1</b>
<b>Regular Mail</b> <input type="checkbox"/> <b>Certified Mail</b> <input checked="" type="checkbox"/>	<b>Tracking #</b>

STATE OF WEST VIRGINIA  
Department of Environmental Protection  
Environmental Enforc

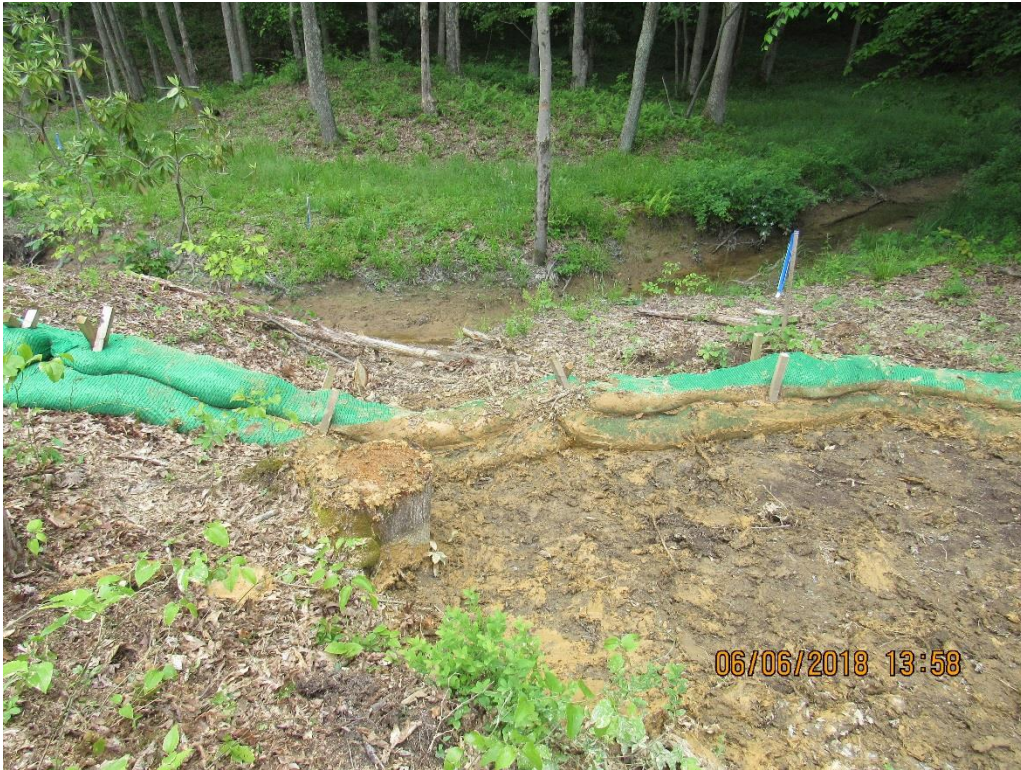
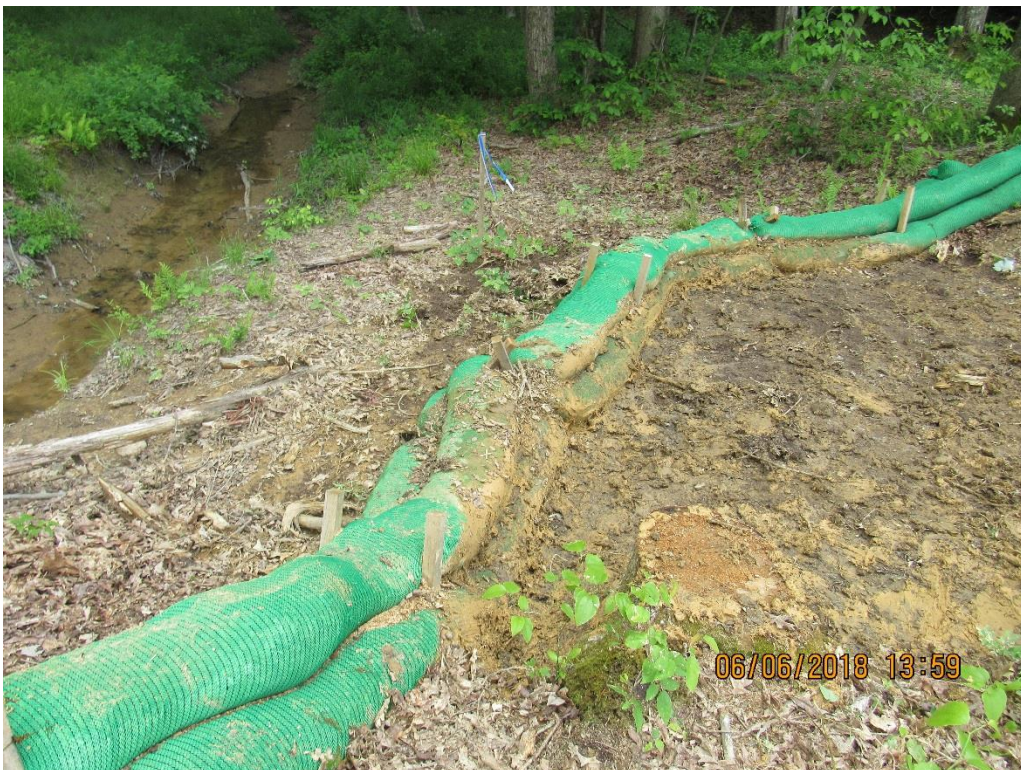
- 1. & 21. Perimeter controls near station 6782+00 (sheet 6.37) had failed. Controls were repaired, but additional controls were not added (Photos 1 & 2). Discussed with Adam and Muggs about additional controls. Both agreed area needs additional controls and decided to add a row of Priority 1 silt fence.

Photo 1: Station 6782+00 control failure repair but additional controls not added.

Photo 2: Station 6782+00 control failure repair but additional controls not added.

- **Section G.4.c. - Permittee has failed to modify your SWPPP when the SWPPP proves to be ineffective in achieving the general objectives of controlling pollutants in storm water discharges- additional controls were not added to areas where installed controls failed.**
- **Section G.4.e.2. - Permittee has failed to implement controls: water bars/slope breakers were improperly installed- did not have outlets, outlet was directed down denuded slope, slope of water bar was inappropriate, and inadequate number of bars were installed.**
- **Section G.4.e.2.A.ii.j - Permittee has failed to prevent sediment-laden water from leaving the site without going through an appropriate device from control failure at stations 6812+58 (sheet 6.38) and 6854+00 (sheet 6.39).**

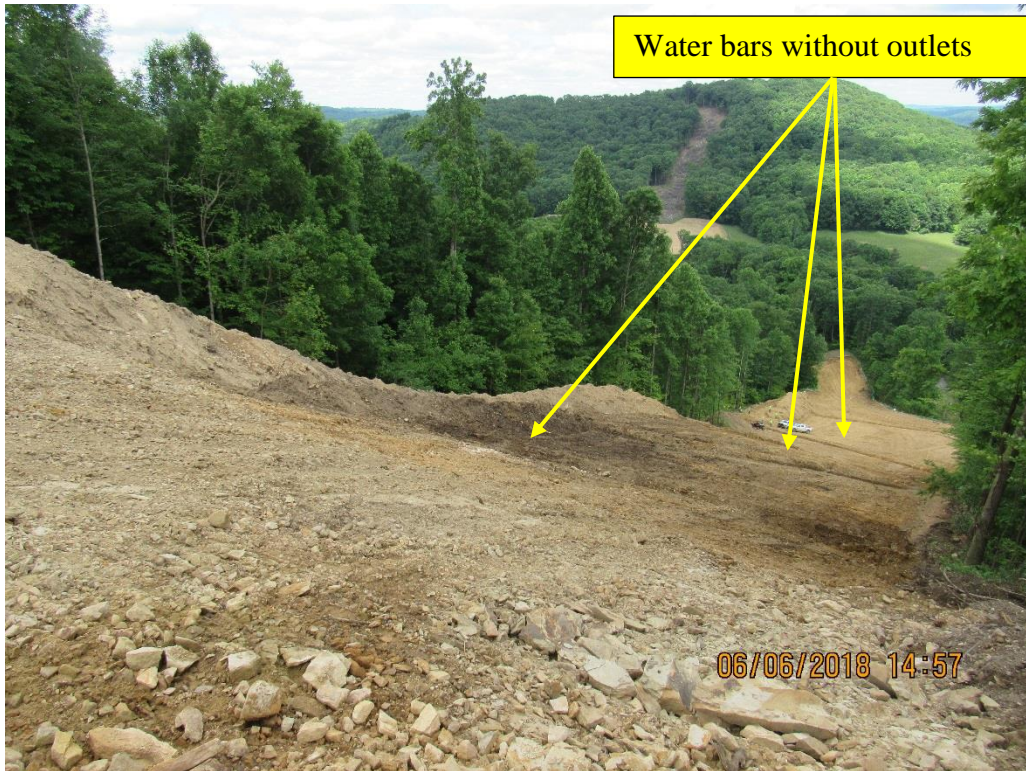
- 7. Water bars near station # 6801+38 (sheet 6.37) with <24° to >30° slope were installed with outlets leading to large pile of soil, outlet over cleared slope, and were installed at a very steep angle. EI Adam Ledbetter did some training/instructing ECD installation crew and equipment operators on proper installation during inspection. Also, inadequate number of water bars/were installed on slopes. Per EI Adam Ledbetter, corrections to water bars would be completed by end of business day on 6/7/2018.

Photo 3: Water bars installed without adequate outlets near station # 6801+38 with  $<24^{\circ}$  to  $>30^{\circ}$  slope.

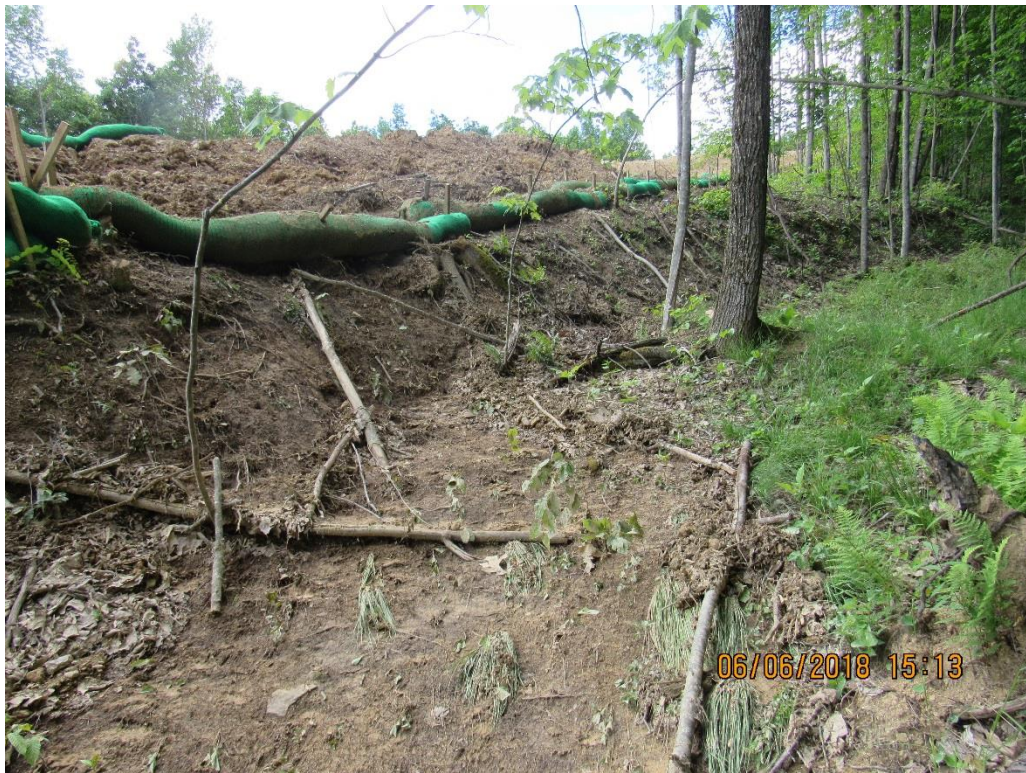
- 19. Evidence of sediment laden water was observed at 2 separate locations where water bar outlets failed at Stations 6812+58 (sheet 6.38) and 6854+00 (sheet 6.39).

Photo 4: Control failure at station 6812+58 allowing sediment laden water to leave site.
