Sacrificial Sand and Bluff Protection: A Story from Nantucket's East End

Erosion and Emergencies in 2013

Geotextile Tube Cross Section and As-built

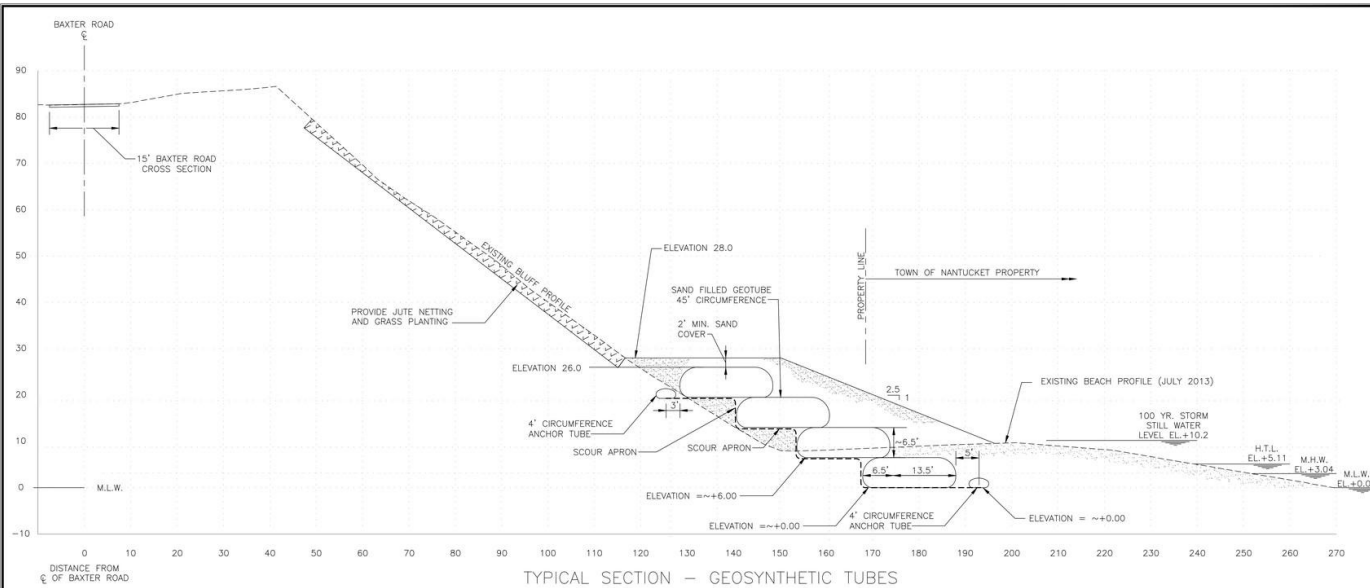
- ALL ELEVATIONS ARE BASED ON MEAN LOW WATER DATUM (M.L.W.=0.0').
- GEOTEXTILE TUBES SHALL OVERLAP IN STEPPED LAYERS WITH THE WIDTH OVERLAPPED TO PROVIDE AN EFFECTIVE SLOPE OF 2:1.

- SLOPE OF GEOTEXTILE TUBE STACK SHALL NOT BE STEEPER THAN 1:2.
- GEOTEXTILE TUBE FABRIC SHALL BE MACCAFERRI MACTUBE OS 500, OR APPROVED EQUAL, WITH EITHER A COMPOSITE OR SHOULD ATTACHED TO THE TOP OF THE GEOTEXTILE TUBE WHERE EXPOSED TO ELEMENTS.

- SCOUR APRON SHALL BE APPROXIMATELY 60' WIDE SO AS TO EXTEND ALONG THE BOTTOM CONTOUR OF STACKED GEOTEXTILE TUBE CONFIGURATION.
- SAND BACKFILL SHALL BE PLACED IN 12" LIFTS AND COMPACTED PRIOR TO PLACEMENT OF UPPER GEOTEXTILE TUBE LAYER, SO AS TO PROVIDE A FLAT STABLE BENCH FOUNDATION FOR THE GEOTEXTILE TUBE INSTALLATION.

TYPICAL CROSS SECTION - TEMPORARY SLOPE STABILIZATION
BAXTER ROAD SLOPE STABILIZATION
 NANTUCKET, MASSACHUSETTS

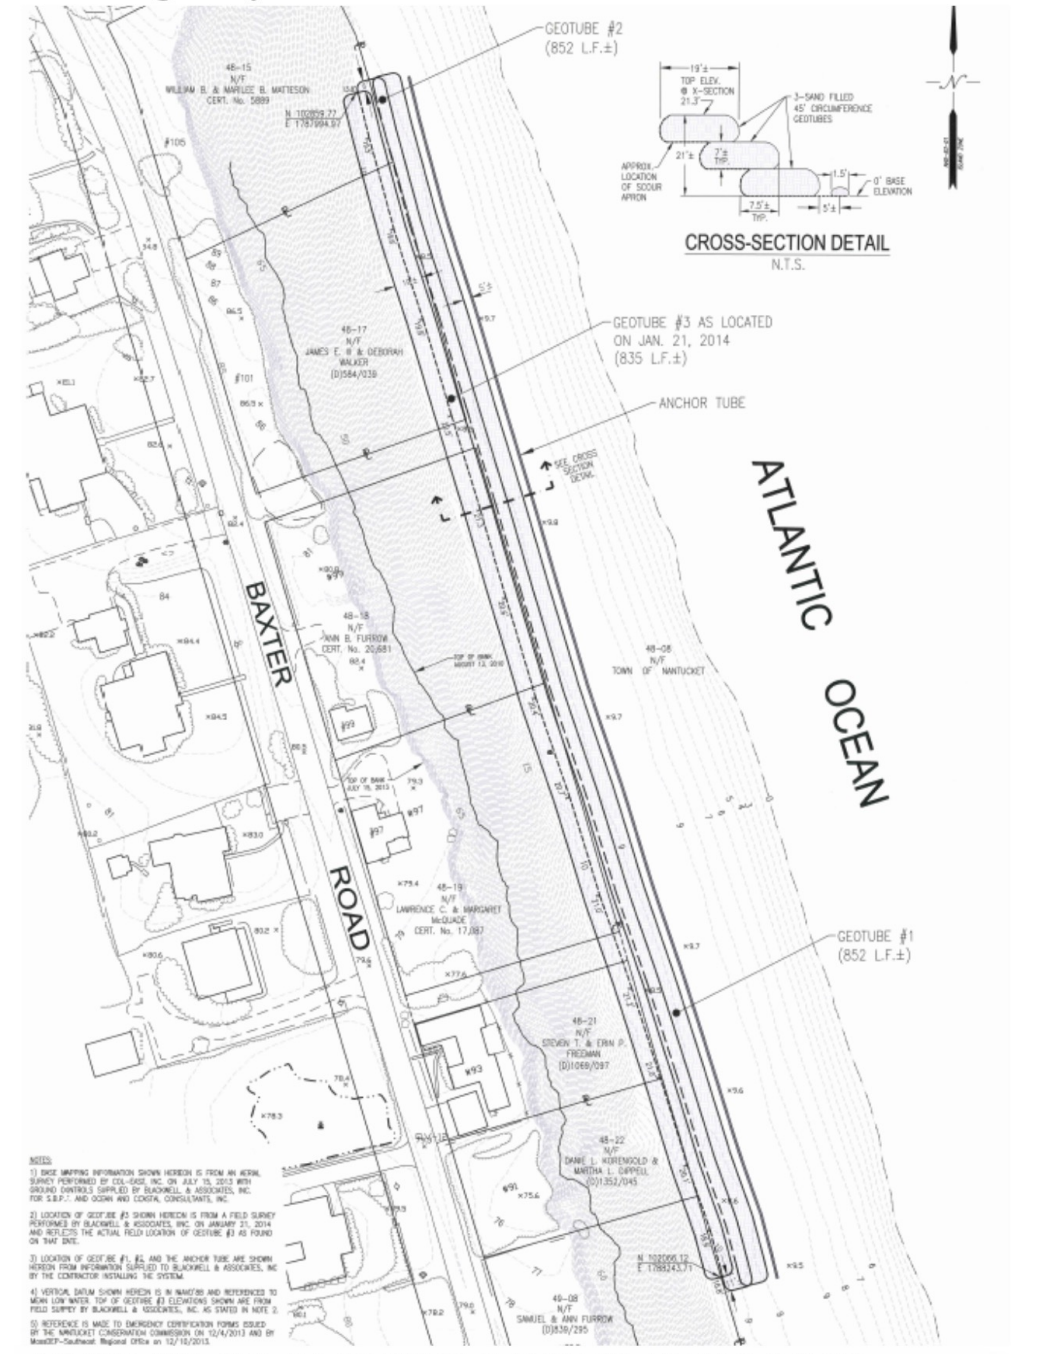
Emergency Installation of Sand Filled Geotubes

As-built provided by Blackwell & Associates, January 27, 2014. Drawn By: Leo C. Asadoorian.

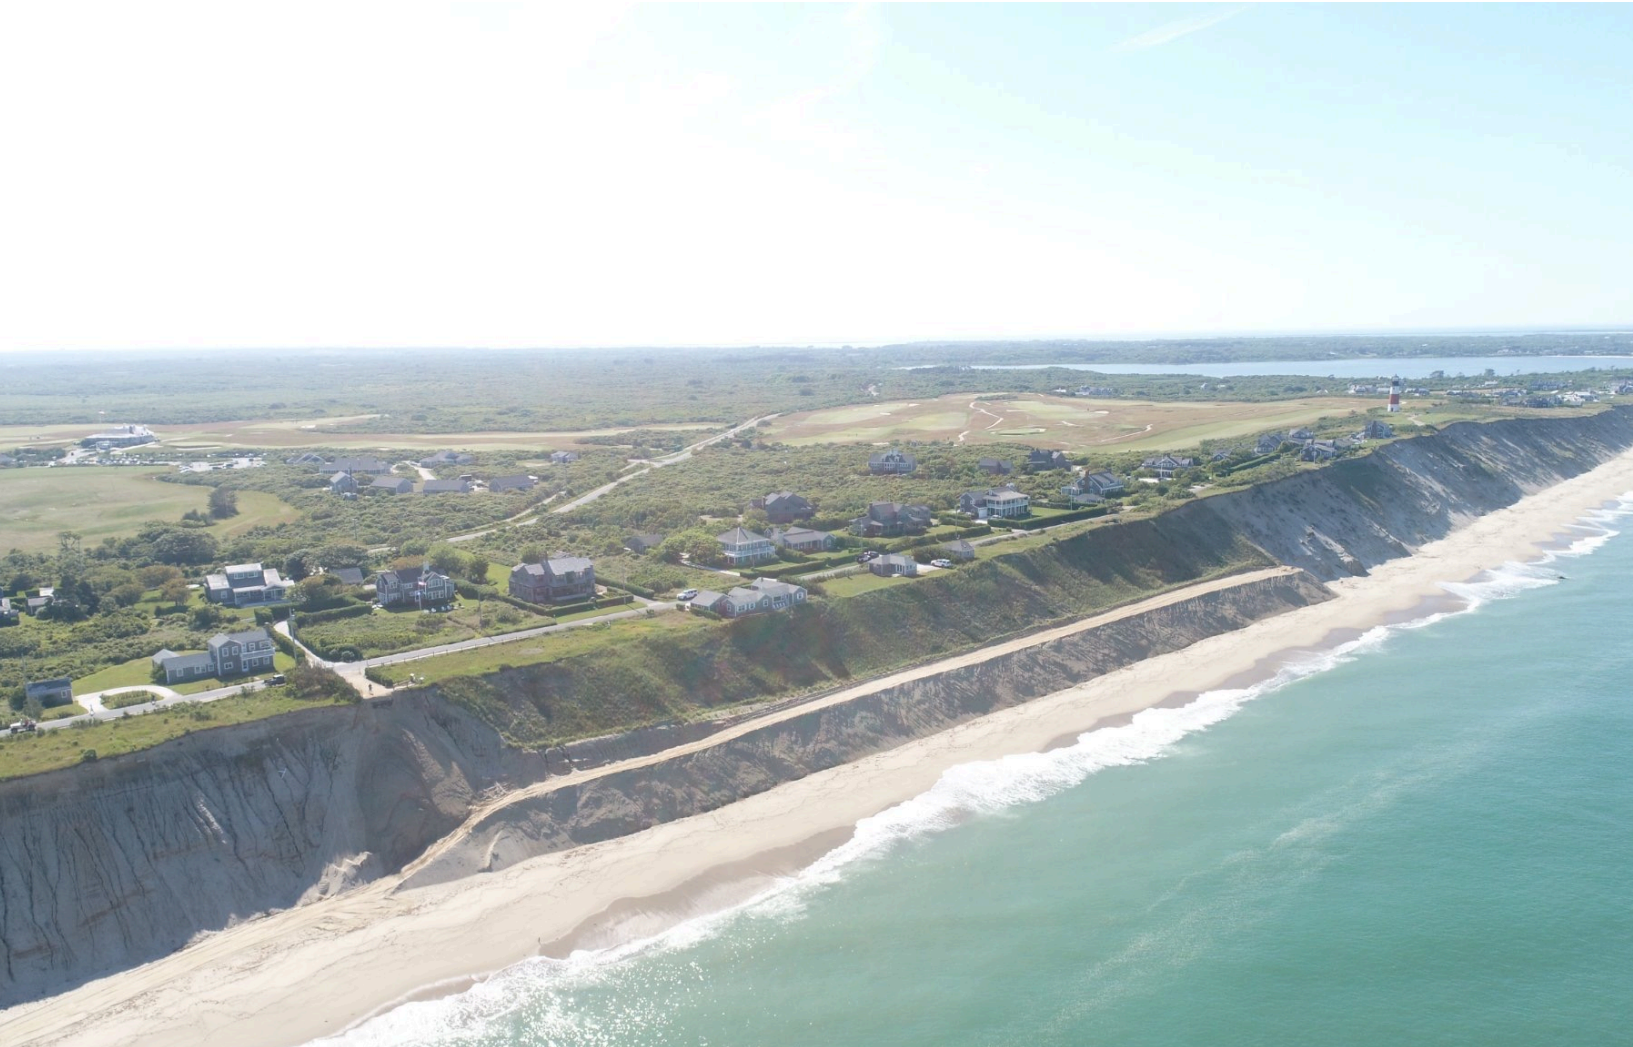
Project Statistics

- Mitigated with 22 cubic yards of sand per linear foot
- Upon completion 39,204.24 cubic yards of sand had been delivered
- At \$27 per cubic yard* that cost roughly \$1,058,514.48 (Cohen 42-43)
- 1,782 dump truck loads (an average load is 22 cubic yards)
- The project was privately funded by SBPF and cost roughly \$3 million (Patel 3)

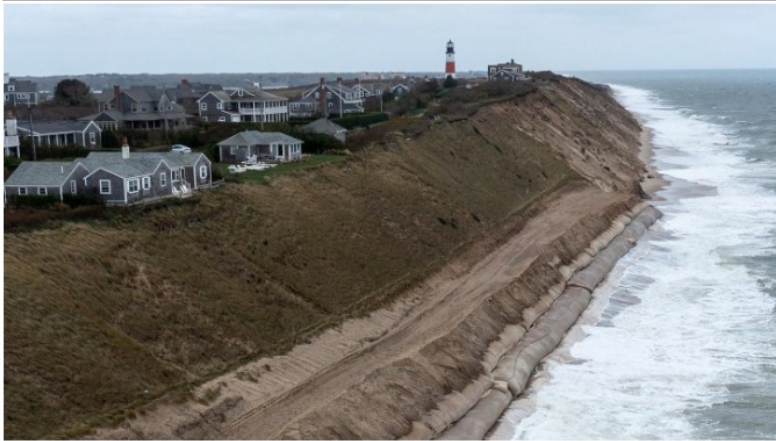
1 ACCELERATED EROSION AT & NORTH OF THE GEOTUBES

*In front of and to the north of the geotubes, the long term net erosion rate has **tripled** from the pre-geotube rate.**

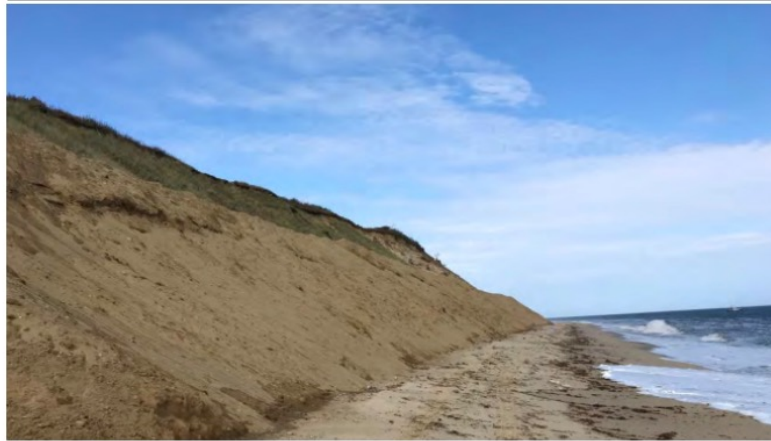
2 NARROWING BEACH IN FRONT OF THE GEOTUBES

*In front of the geotubes, the walkable beach has narrowed by approximately **-57%** in the 7 years after they were installed.**

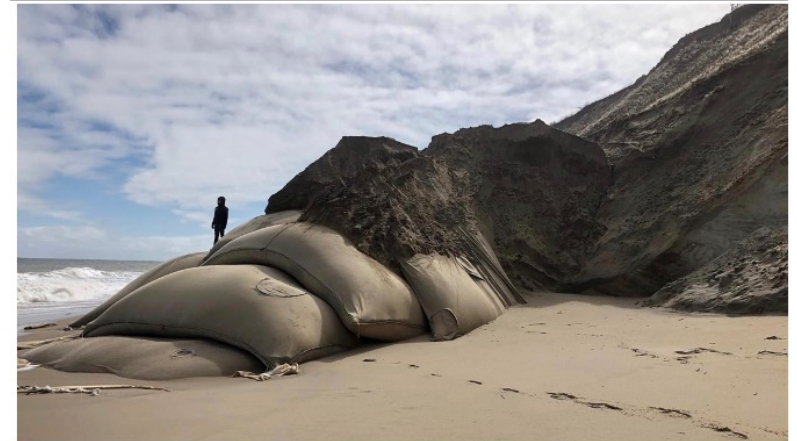
3 BLUFF BASE EROSION JUST NORTH OF THE GEOTUBES

*The toe of the bluff at the north end of the geotubes has **receded roughly -24'** since the geotubes were installed.**

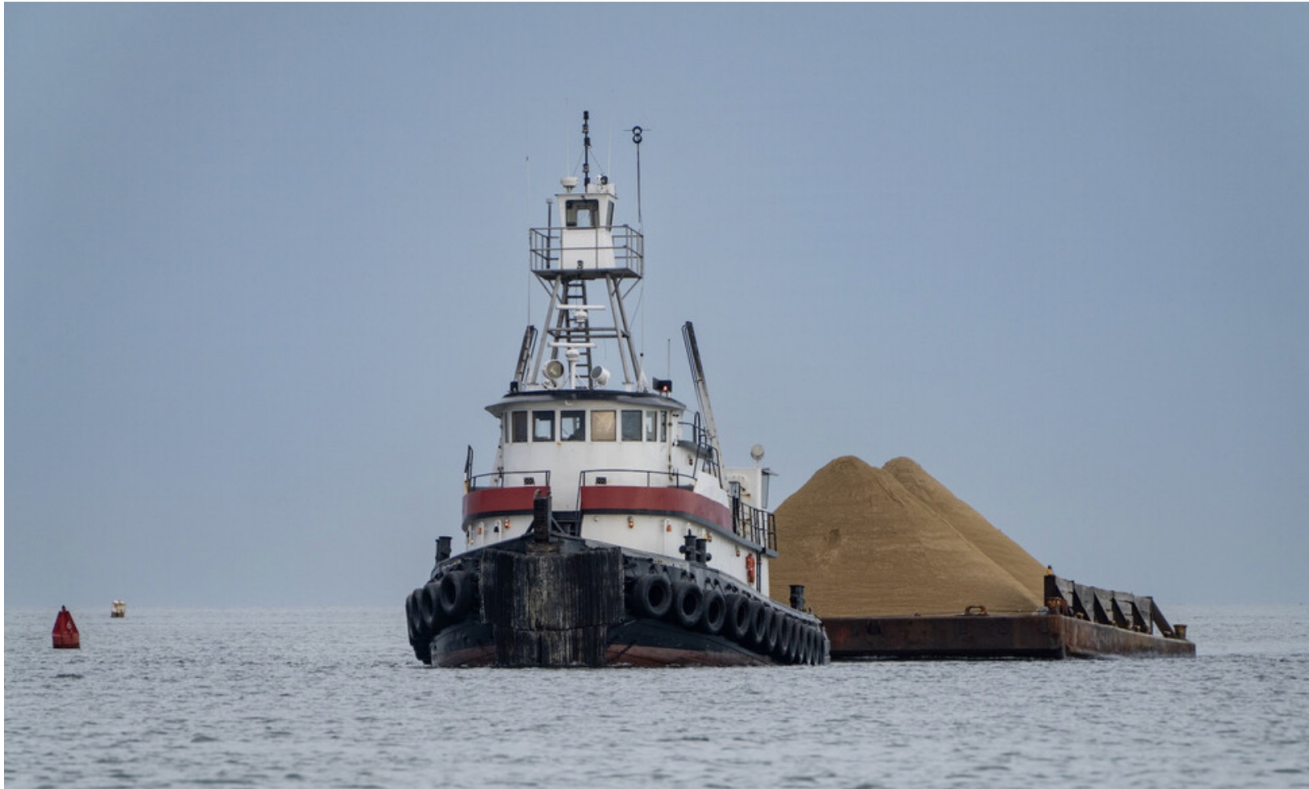
Graphic from Nantucket Current

- *3,300 tons (6.6 million pounds) of sand was delivered via barges in early February 2024.
- *The template material originated from Plymouth, MA.
- *The sand was loaded into trucks and driven to New Bedford where it was loaded onto three barges and towed to Nantucket. (Graziadei 2024)

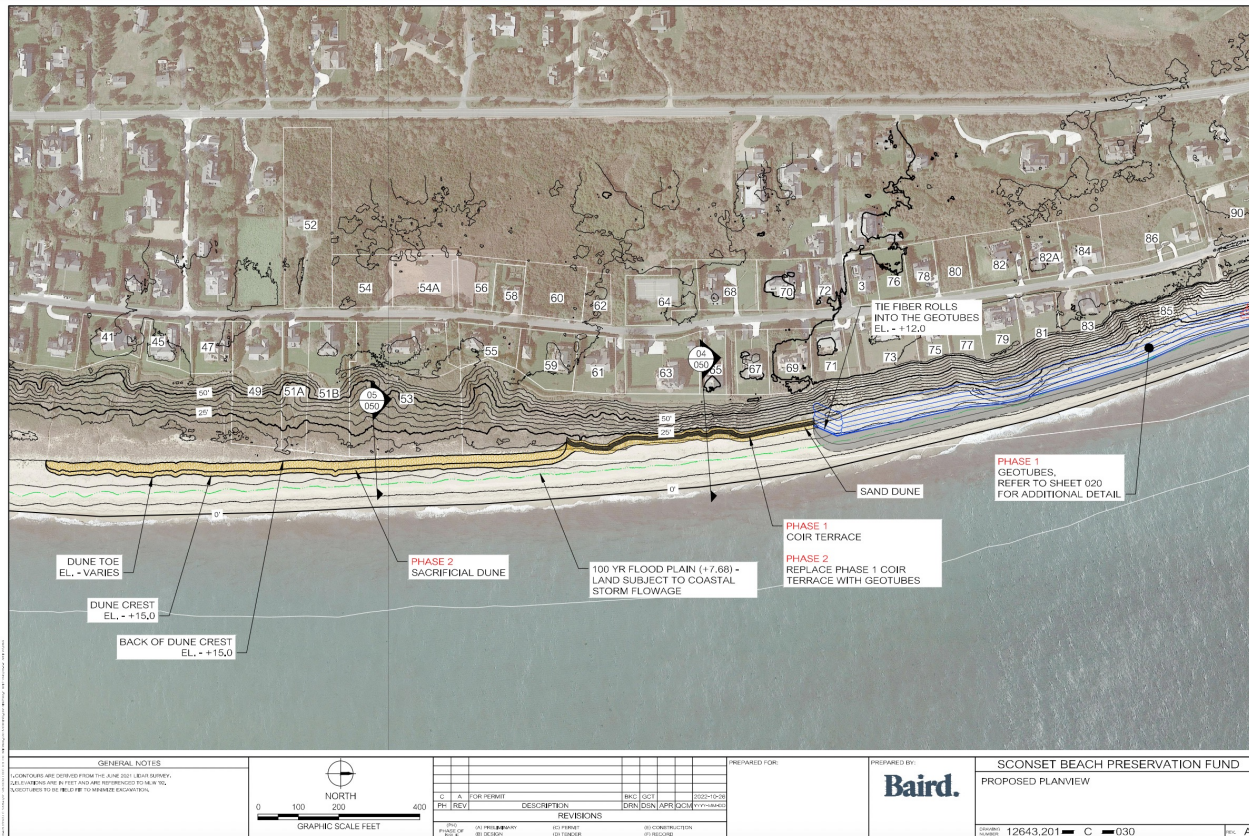
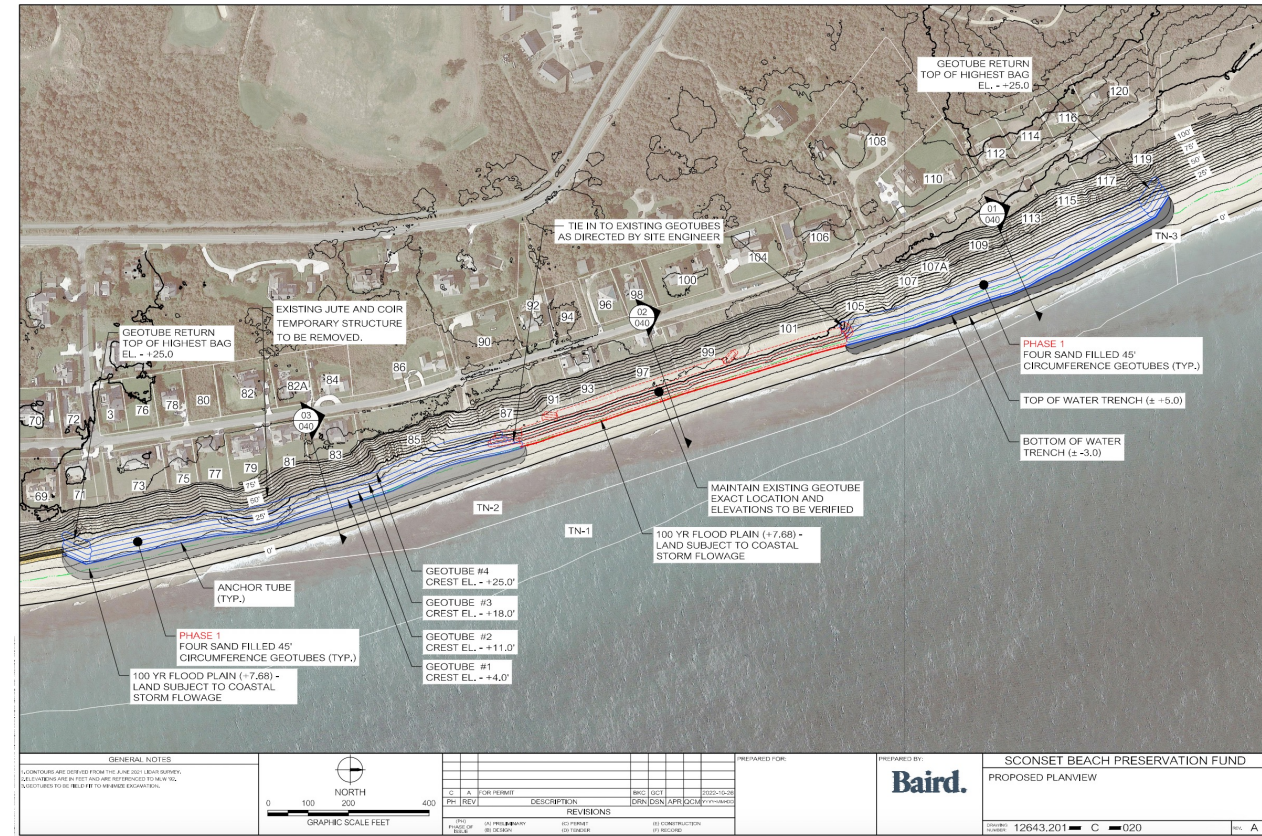
Figure 14
Basis of Coastal Engineering Design

Baxter Road & Sconset Bluff Stabilization and Coastal Resiliency Project Nantucket, MA
