## A Review of the Former Marble Quarry Landfill Site

*Hughes Environmental Consulting Services*  
*157 Strong Ave., Syracuse, NY 13210*

**February 29, 2016**

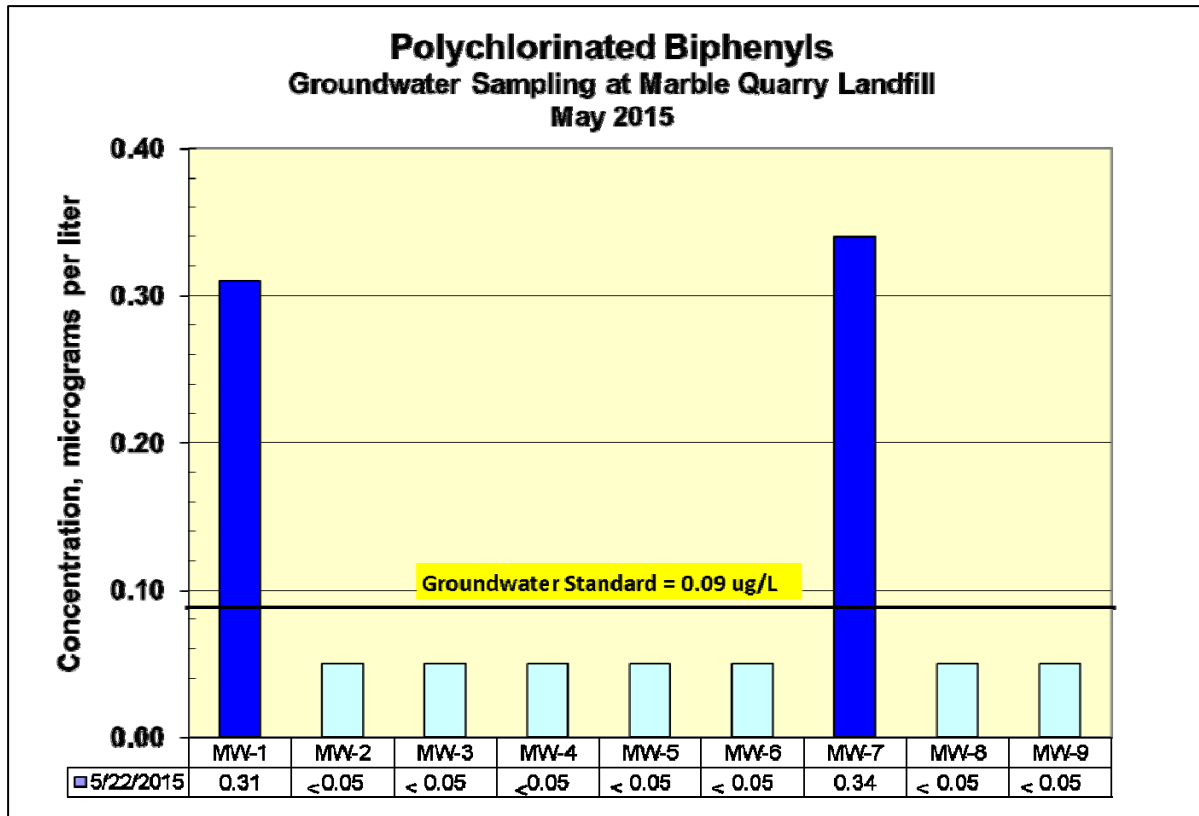
PCBs were found above groundwater standards in samples from two wells in May 2015: MW-1 and MW-7 (see Figure 2B.). Both samples were quantified as Aroclor 1260, which indicates electrical transformer oil as the probable source. No PCBs were reported in the December samples, but high laboratory reporting limits (~0.5 µg/L) may have made it impossible to find PCBs.

The compound phenol, which has an ambient groundwater standard of 1 µg/L, was found above this standard in several groundwater samples in May and December 2015. (See Figure 2B.) Concentrations in May ranged as high 100 µg/L (in MW-9), but only 1.2 µg/L in December. The reason for the wide discrepancy in results is unknown.

Figure 2B. Groundwater results for PCBs and phenol compared to NYS ambient water standards.

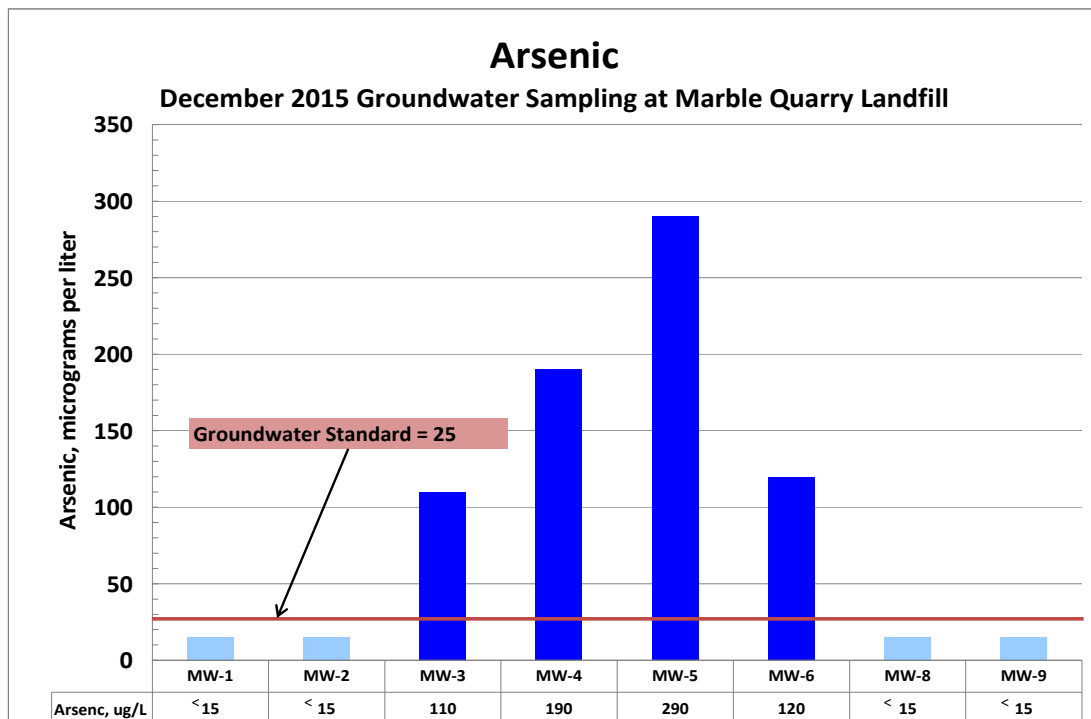
**Figure 2C. Groundwater results for antimony and arsenic compared to NYS ambient water standards.**

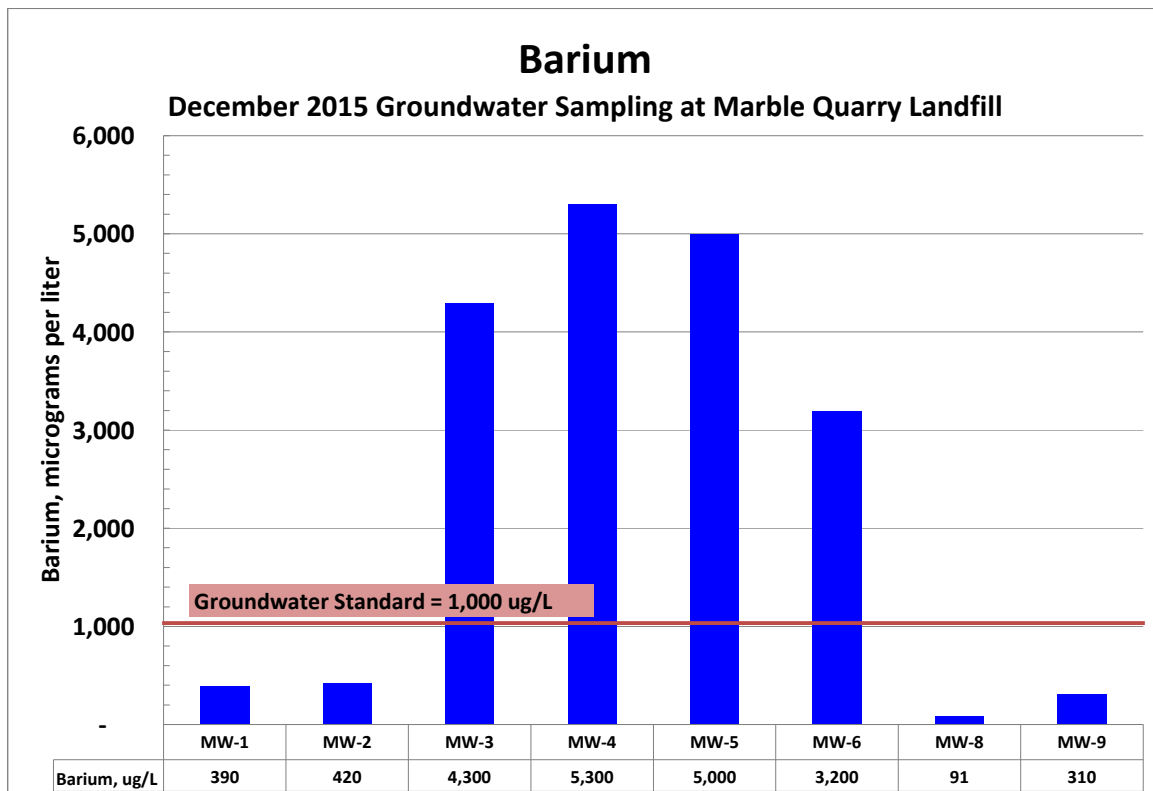
**Figure 2D. Groundwater results for barium and cadmium compared to NYS ambient water standards.**

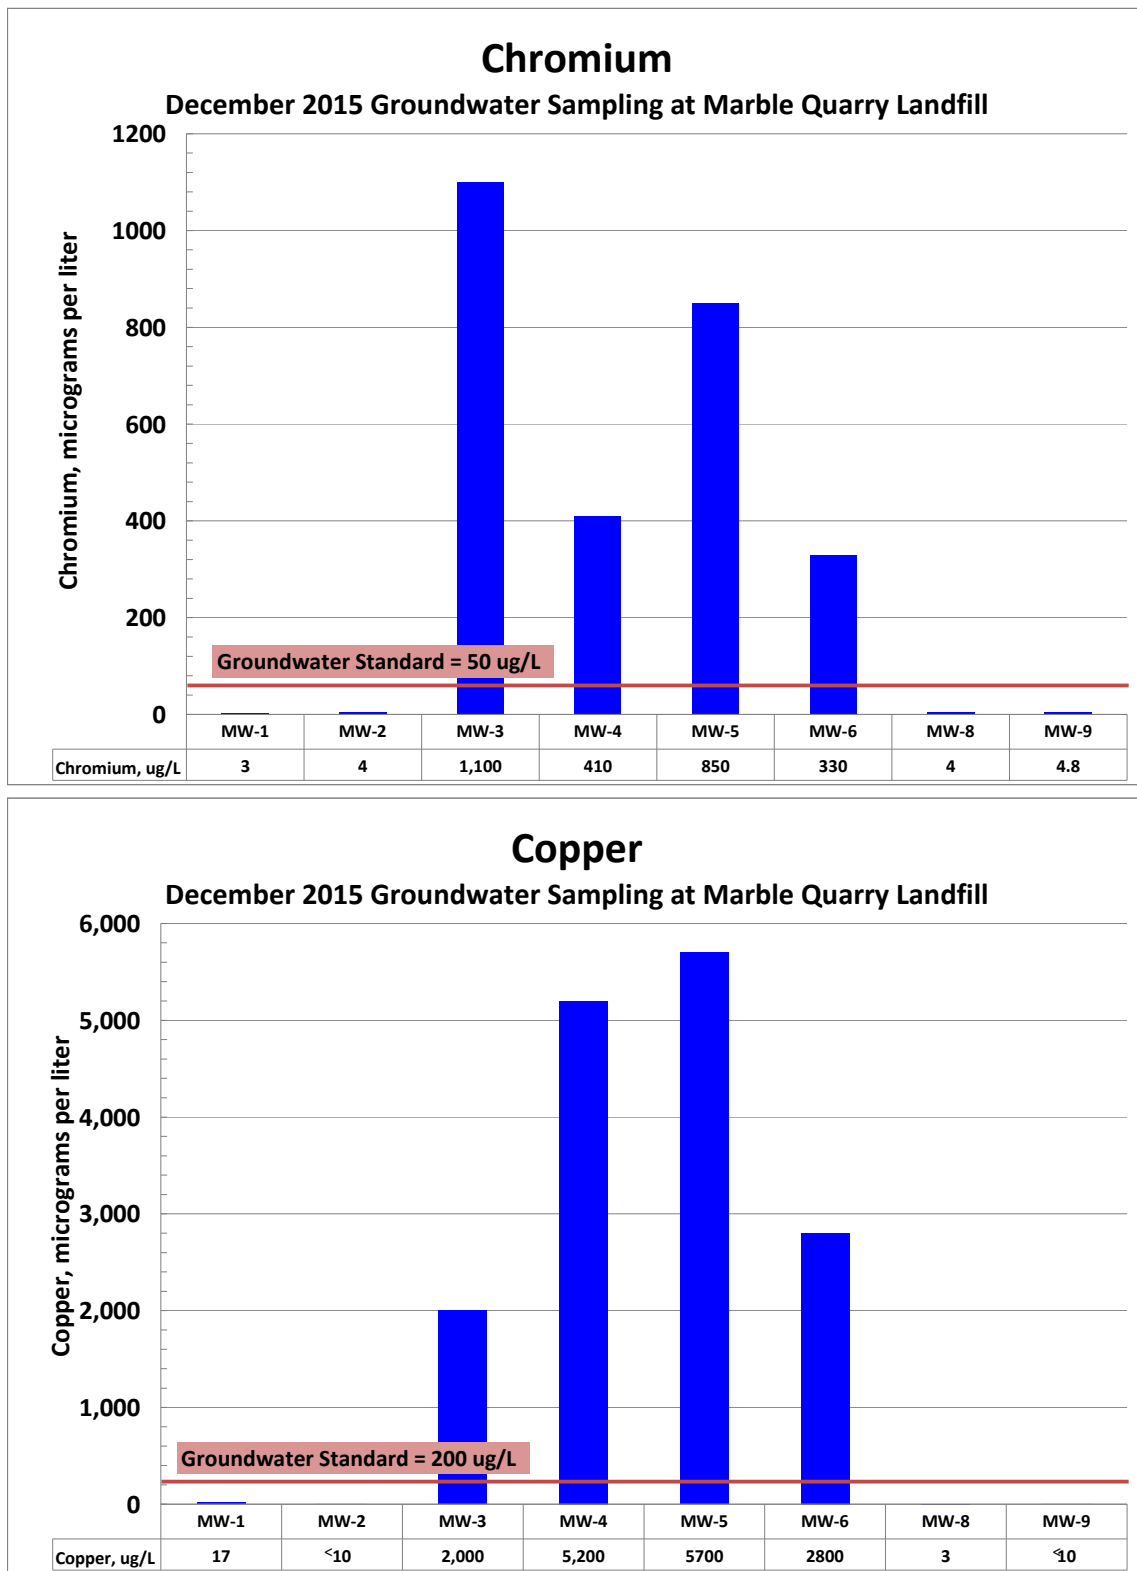
- Copper exceeded the standard of 200 µg/L in MW-3, -4, -5, and -6 (up to 28 times)
- Mercury exceeded the standard of 0.7 µg/L in MW-3, -4, -5, and -6 (up to 23 times)

**Figure 2E. Groundwater results for chromium and copper compared to NYS ambient water standards.**

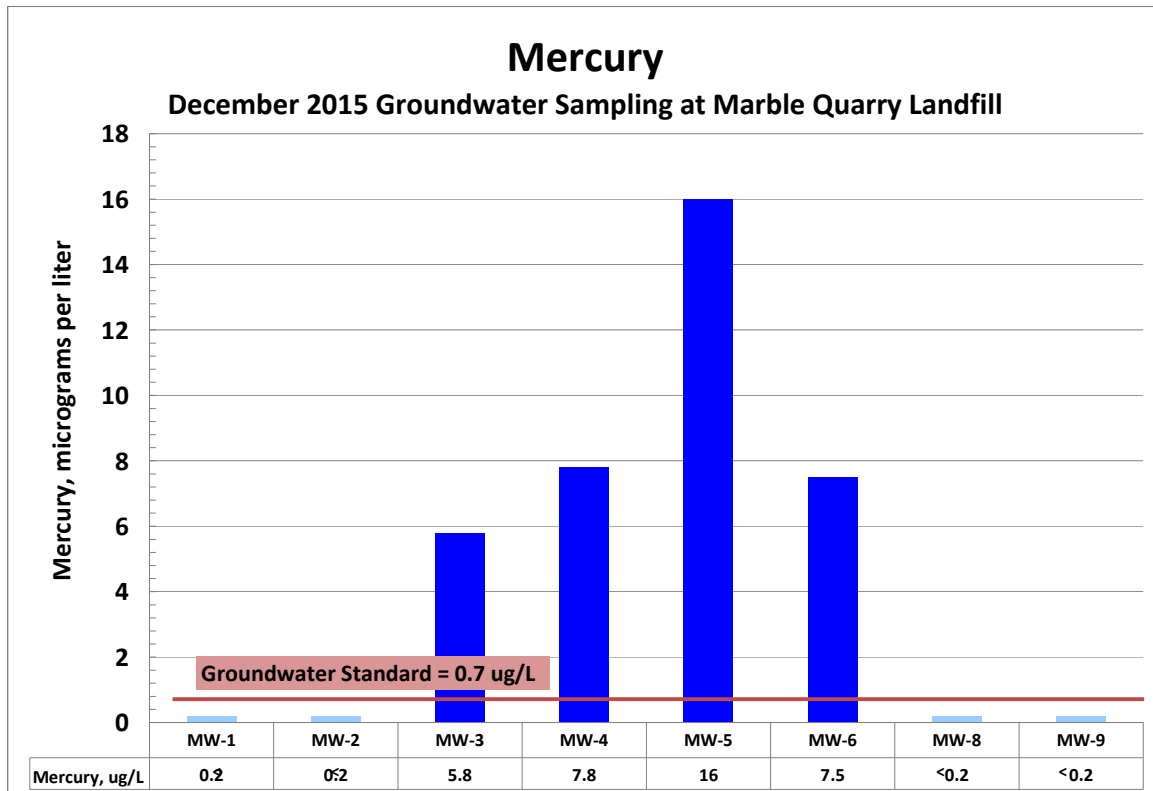
- Nickel exceeded the standard of 100 µg/L in MW-3, -4, -5, and -6 (up to 12 times)
- Lead concentrations were extremely high in MW-3, -4, -5, and -6, ranging from 5,500 to 34,500 µg/L; groundwater in these four wells exceeded the standard of 25 µg/L by factors of 220 to 1,380 times. MW-1 also exceeded the standard, but only by a factor of about two.

**Figure 2F. Groundwater results for mercury and nickel compared to NYS ambient water standards.**

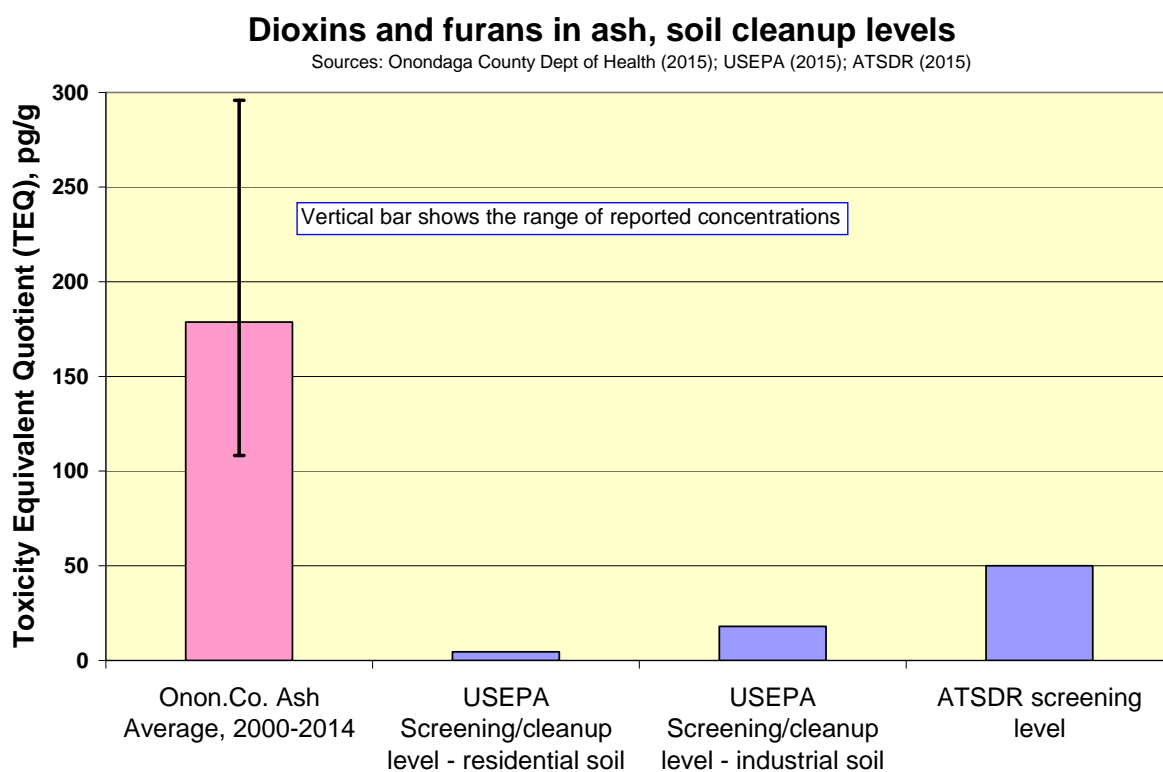
Therefore, it is very reasonable to expect that dioxins and furans are present at the site at elevated concentrations—high enough to pose a risk to humans and animals. These compounds should certainly be investigated in the future, especially in soil vapors and groundwater, since these are the major pathways for off-site exposure. There is no way to know what levels of dioxin and furan contamination exist at the Site without conducting such tests.

**Figure 4.** Polychlorinated dioxins (PCDDs) and furans (TCDFs) in ash from the Onondaga County Resource Recovery Facility, compared with soil clean-up and screening levels.

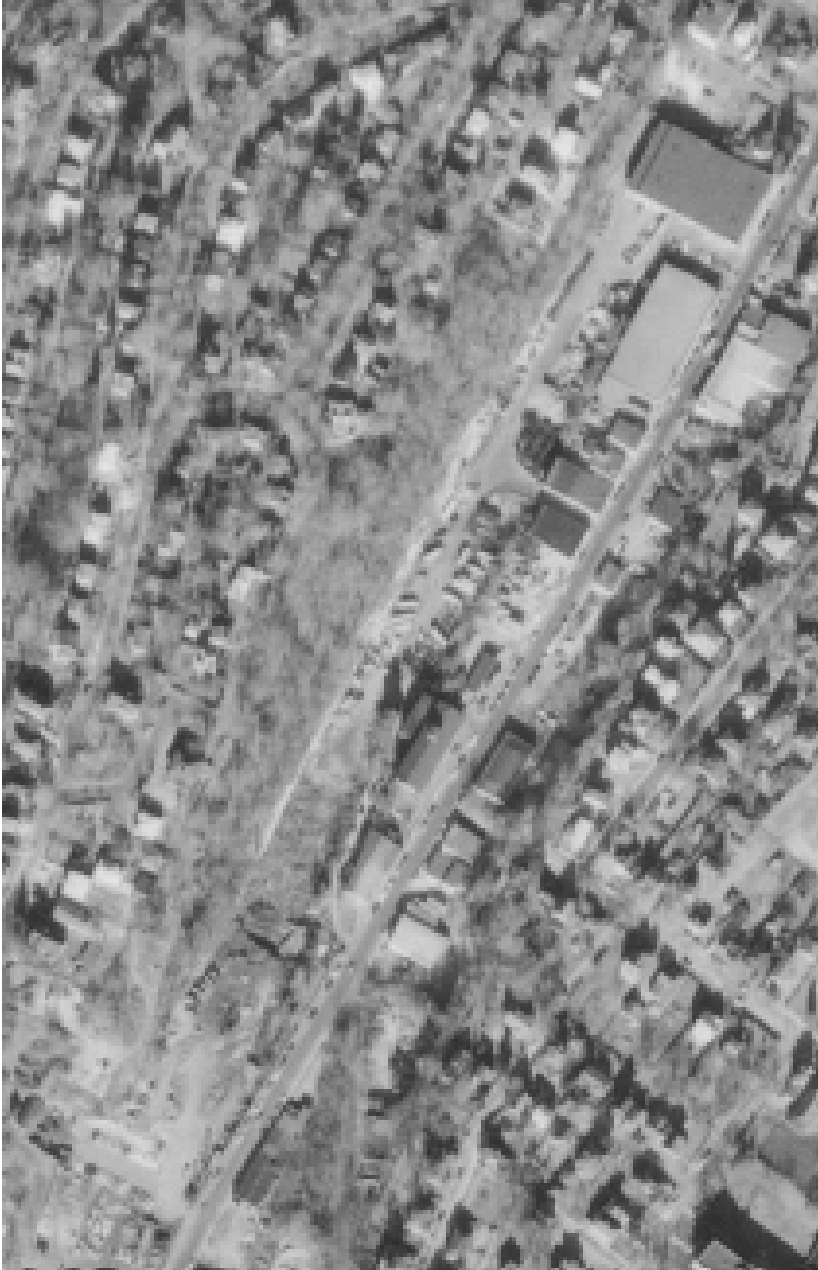
Aerial photo, dated January 12, 1966

The northern hole is much the same as in 1964, a parking area. The southern hole is still below the surrounding land surface, but appears to be more filled in compared to 1964.
